TENSILE CRACK EXPOSURE TESTS

Report 3

LABORATORY EVALUATION OF SERIES "A" BEAMS
WITH RESULTS FROM 1951 TO 1975

Structures Laboratory
U.S. Army Engineer Waterways Experiment Station
P. O. Box 631, Vicksburg, Miss. 39180

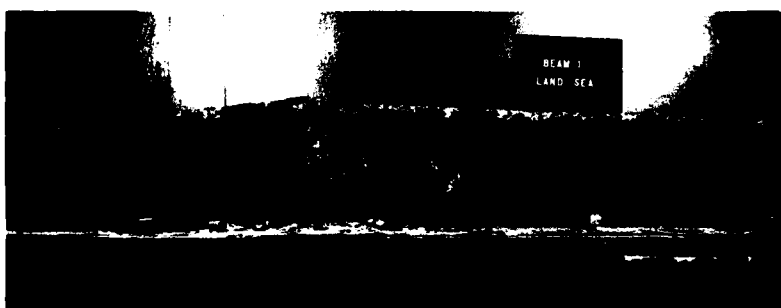
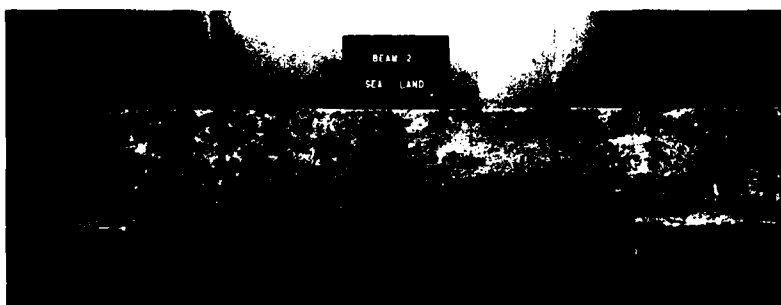
31. Photographs 3-22 show the "as received" condition of ten of the beams. The surfaces of the beams were still moist with sea-water when they were taken from the bituminous membrane, and they had not been subjected to any drying in transit. As can be seen in the photographs there was considerable spalling of the cover over the reinforcement. The spalled areas range in length from 1-1/2 in. long, where no reinforcement had been exposed to nearly the entire length of the beam, exposing the major amount of reinforcement. The spalls were deep enough to expose at least half of the bar and generally occurred in the area of the flexural cracks, although some spalls did occur at the ends of the beam away from the flexural areas.

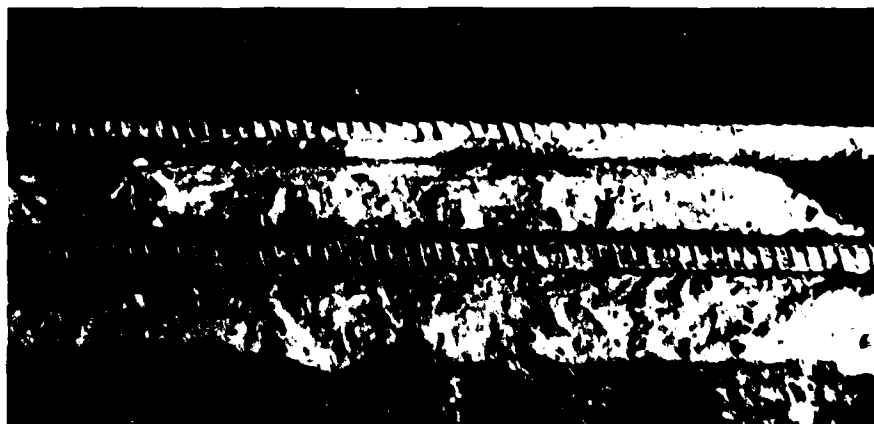
Photo 36. Uncorroded condition of reinforcement bar
